To: LAWSS Board
Cc:
From: Susan MacFarlane
Date: 2017-01-19
Re: LAWSS acquiring the Brigden and Wyoming Water Towers

Wyoming Water Standpipe
Wyoming, Ontario

Interior Coating Repair Inspection

May 3 - 6, 2016

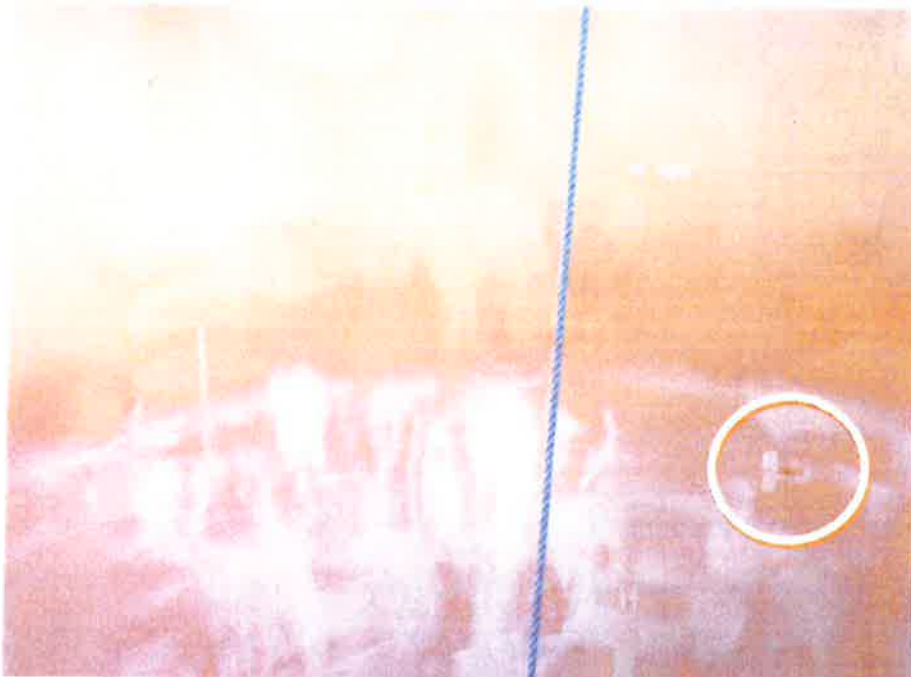
From a general observation, the overall lining appears to be in good condition. There are several sites where a white coloured coating has been applied to the original coating. There are several sites where the white, touch up material displays small corrosion stains within it. Although for the most part, more recently applied material appears to be tightly adhering. See Images #1, 2 & 4 for examples.

Image #1. May 3rd. Generally, the interior coating appears in reasonable condition.

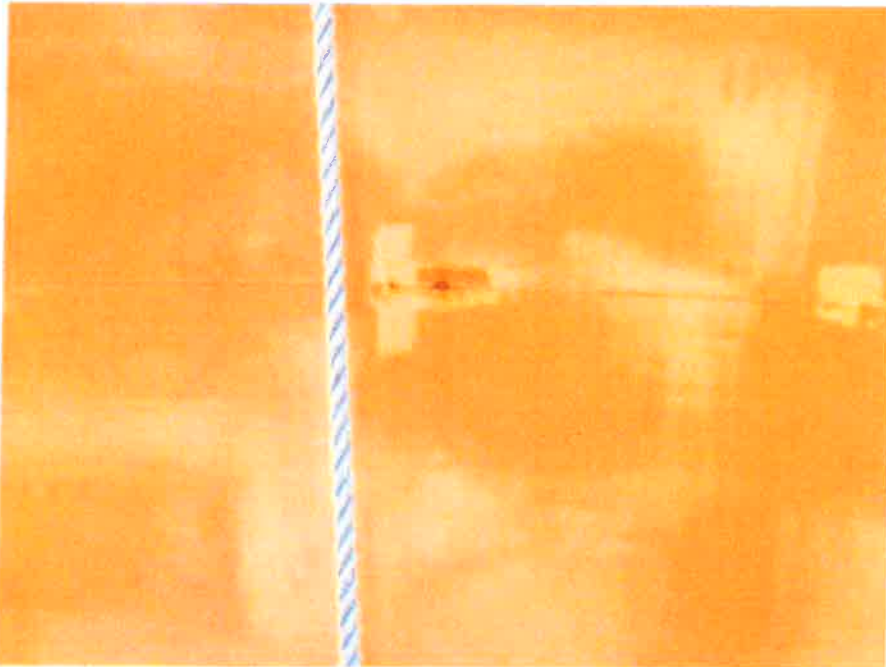
Areas that require attention, for general maintenance, are mostly seen along weld seams. A number of these were inspected after being prepared for coating. In each instance, the surface preparation complied with the coating suppliers specification. See Images #1, 2 & 4 for examples.

Image #2. May 3. The majority of repairs were noted along weld seams.

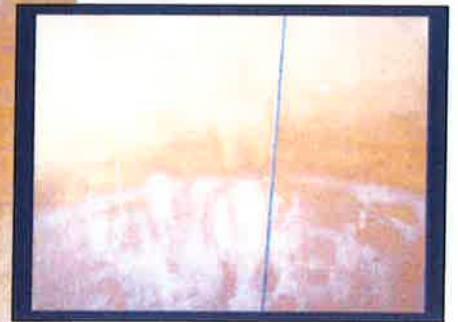
There is a significant amount of a white staining visible throughout the vessel up to, what is believed to be the usual 'fill line'. Close inspection shows that white staining material can be easily removed from the surface. See Images #1 - 4 for examples.

Image #2. May 3. There is a white haze on much of the surface below the normal fill line.

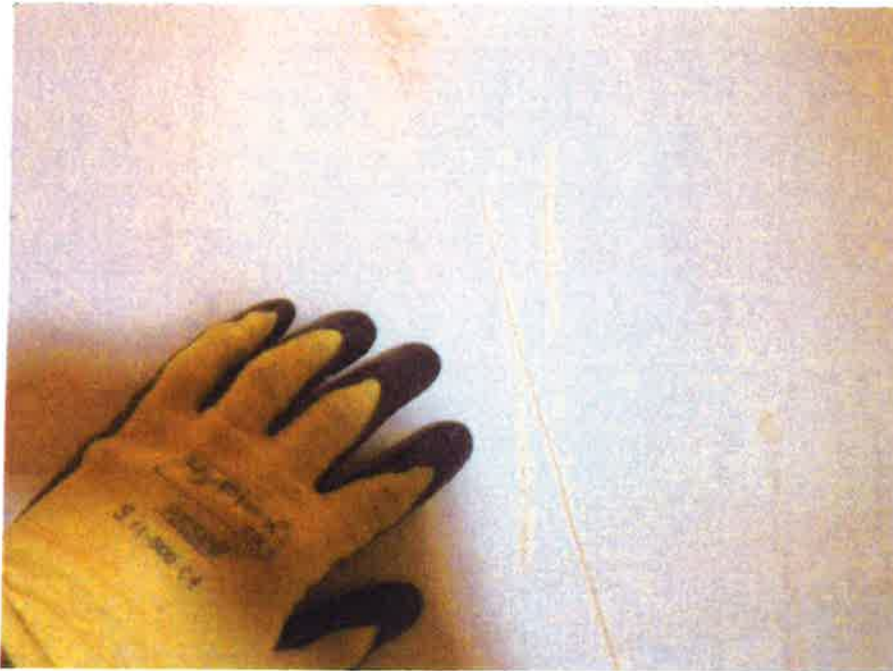
Image #3. May 3. This haze can be easily removed.

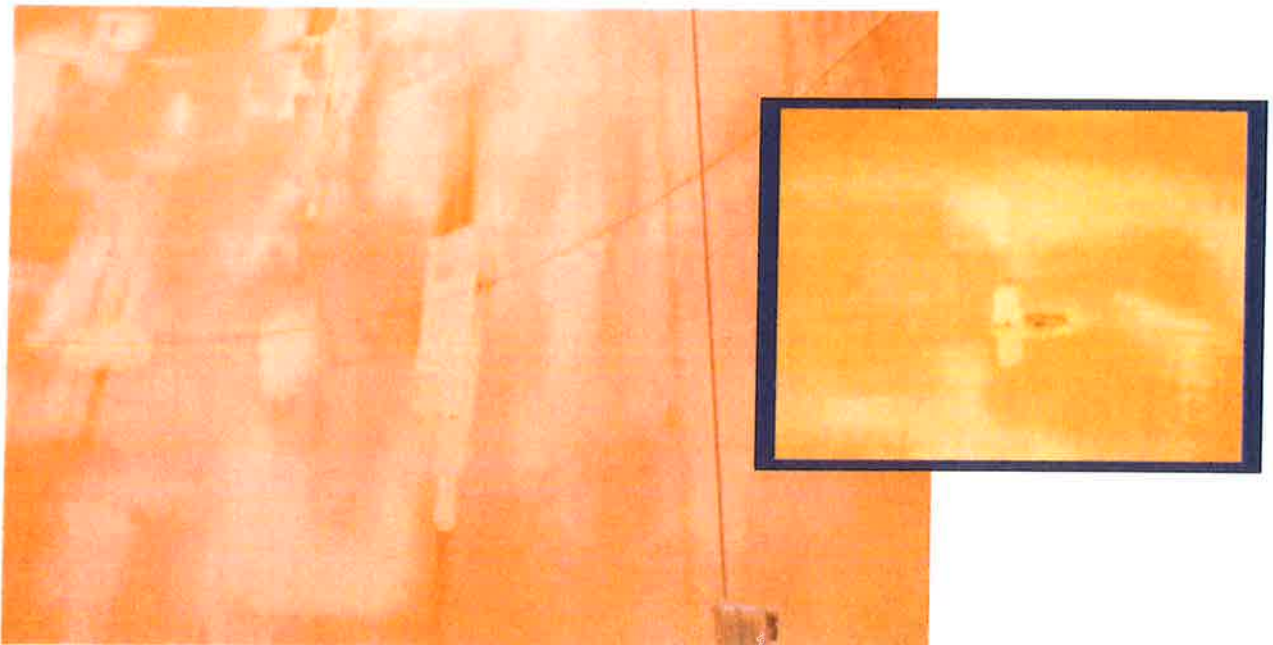
Image #4. May 3. There are a number of sites that have been previously repaired. Most of these are intact, while some have corrosion staining visible within them.

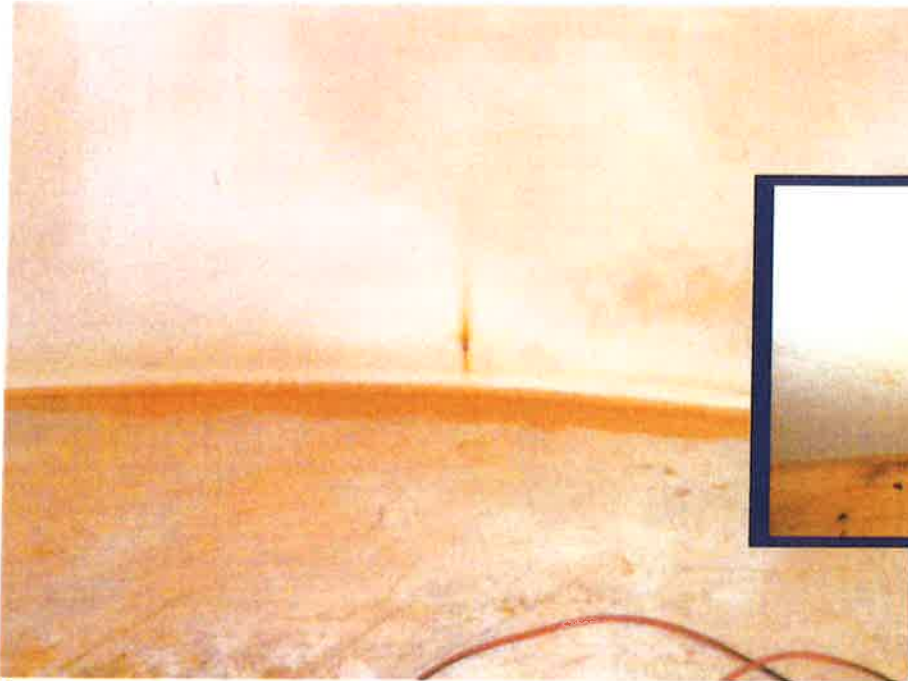
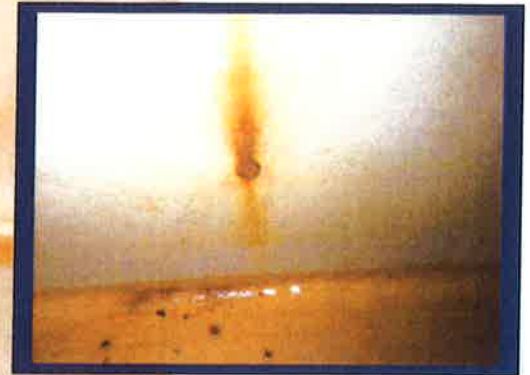
Image #5. May 3. There are a number of small corrosion sites visible.

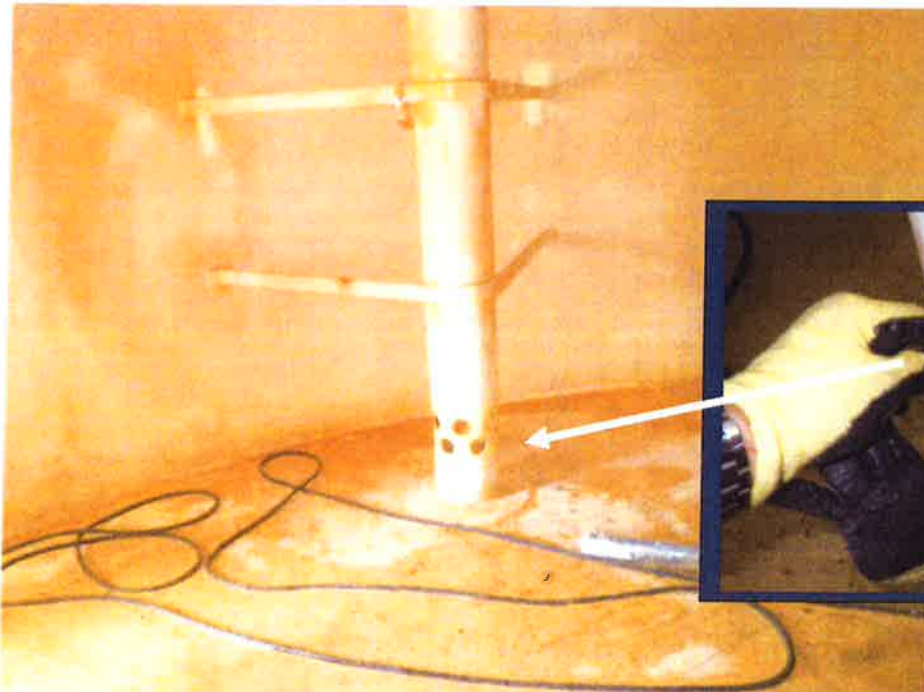
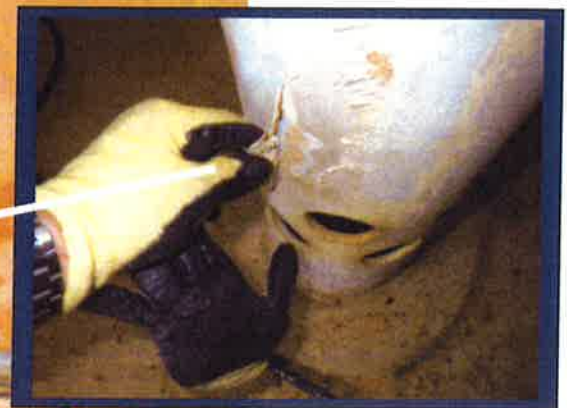
Image #6. May 3. The lower area of the fill pipe where failed coating was noted, although there isn't any significant corrosion visible.

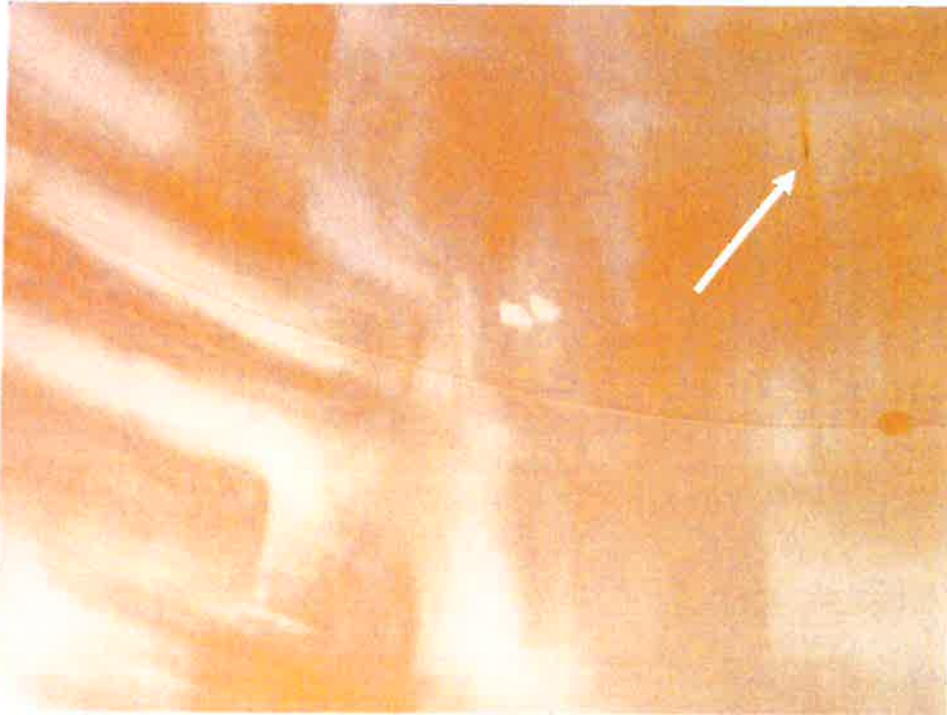
Image #7. May 3. There are a number of small corrosion sites visible.

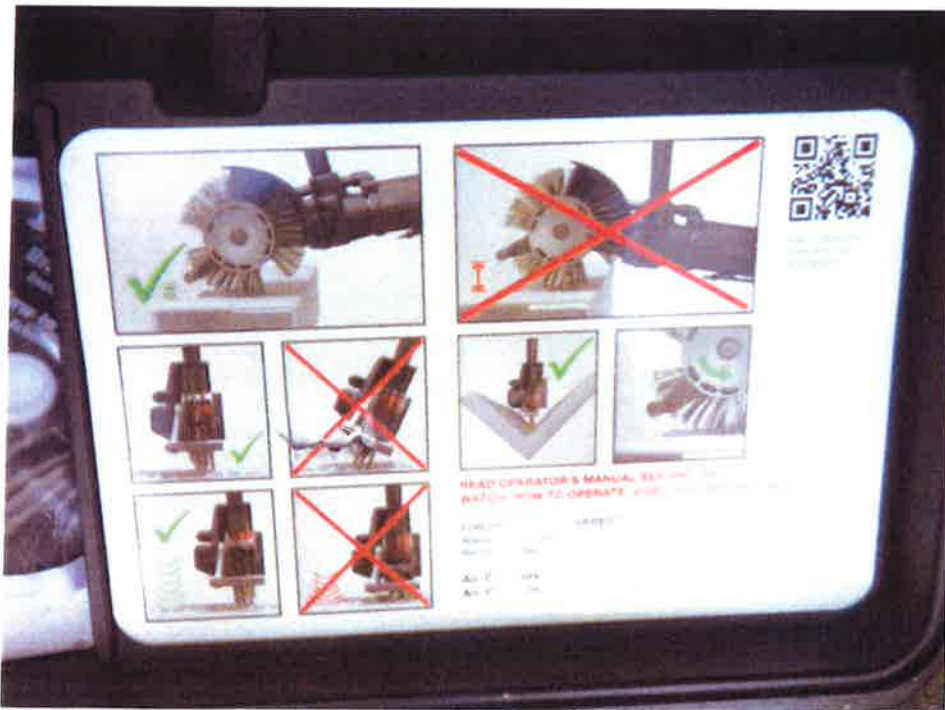
Image #8. May 4th. Surface preparation is being addressed using a 'bristle blaster'.

The contractor advised that each site to be repaired will power tool cleaned as per SSPC-SP3 utilizing a 'bristle blasted'. This is a power tool that is designed to remove all loose rust and failed coating, while imparting a profile to the cleaned surface. See Images #8 & 9 for details. The coating will be mixed and applied as per the coating suppliers specifications.

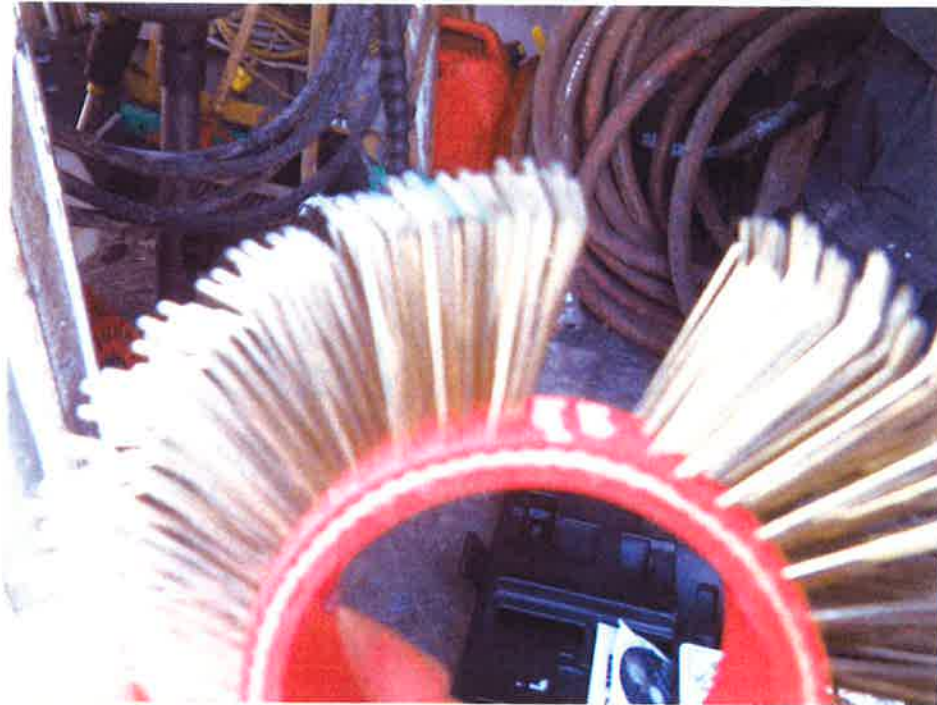
Image #9. May 4th. This unit removes failed paint and rust while imparting a profile to the surface.

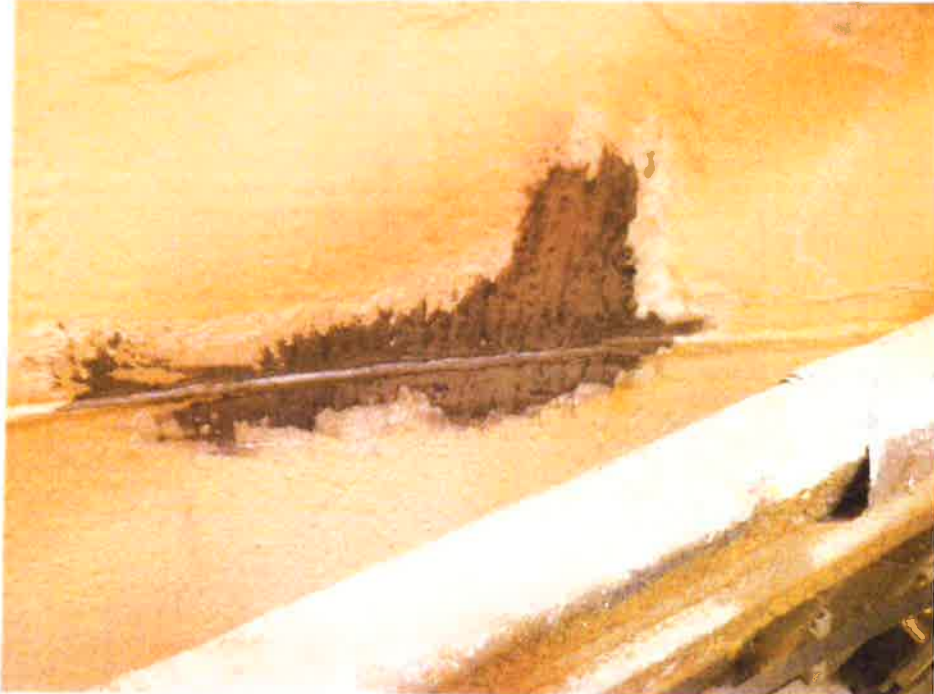
Image #10. May 4th. Note how the coating around the repair site has been feather-edged to ensure that there are no loose edges.

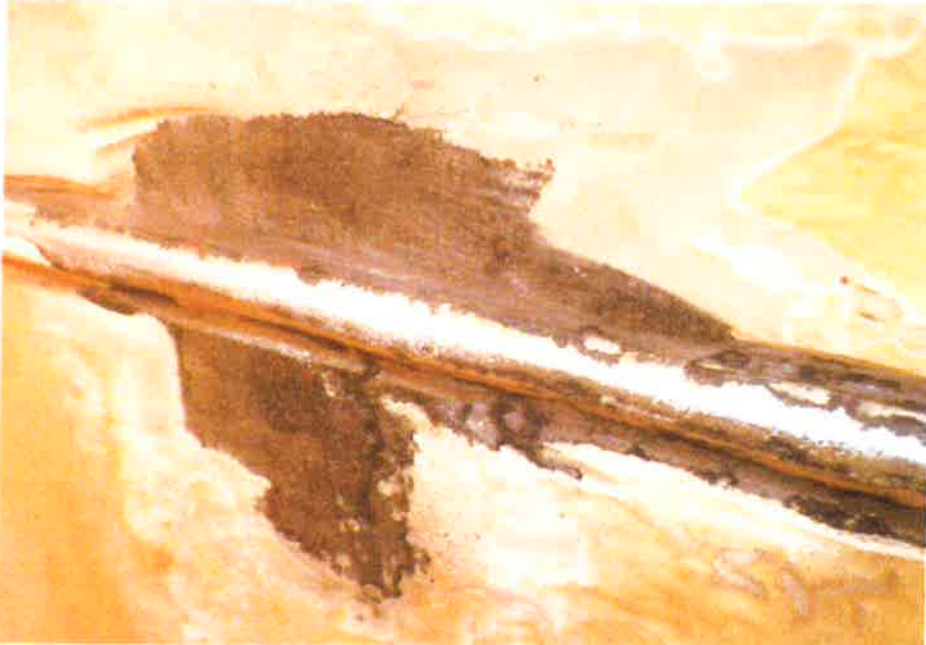
Image #11. May 4th. Note surface profile visible in the bare steel, which is ideal for the requirements of the coating at application.

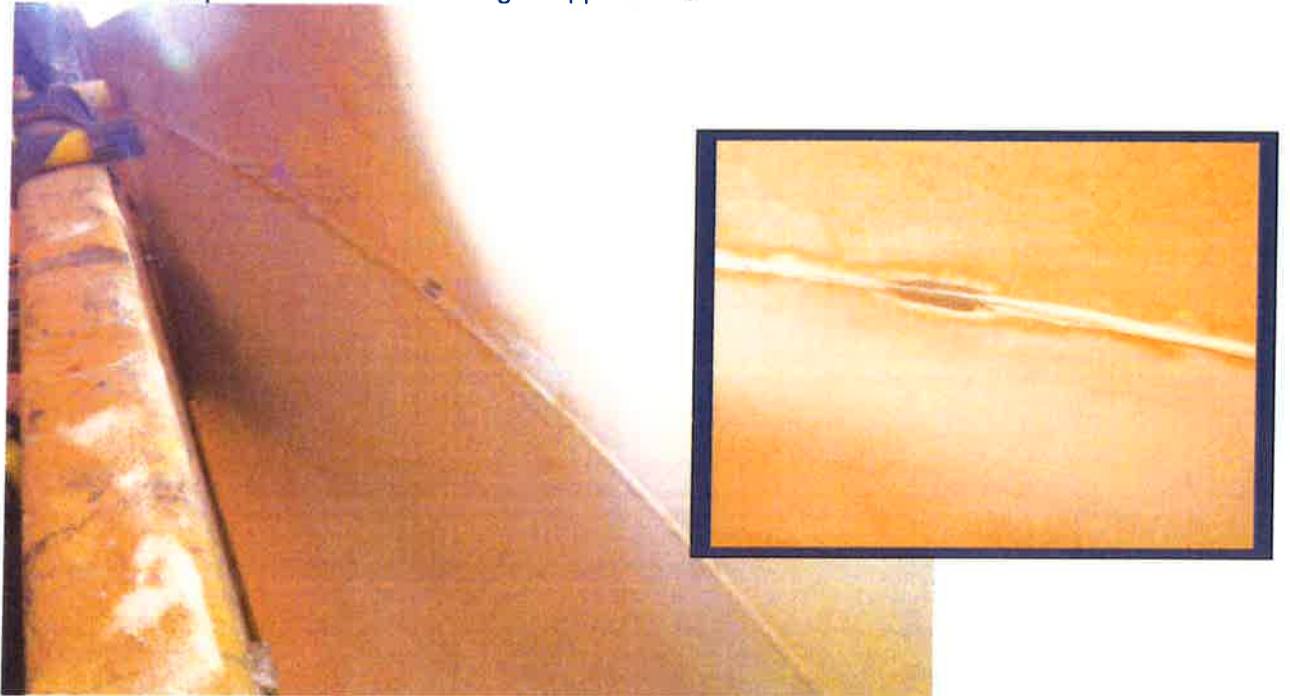
Image #12. May 4th. Repair site along a weld seam following surface preparation using the bristle blaster.

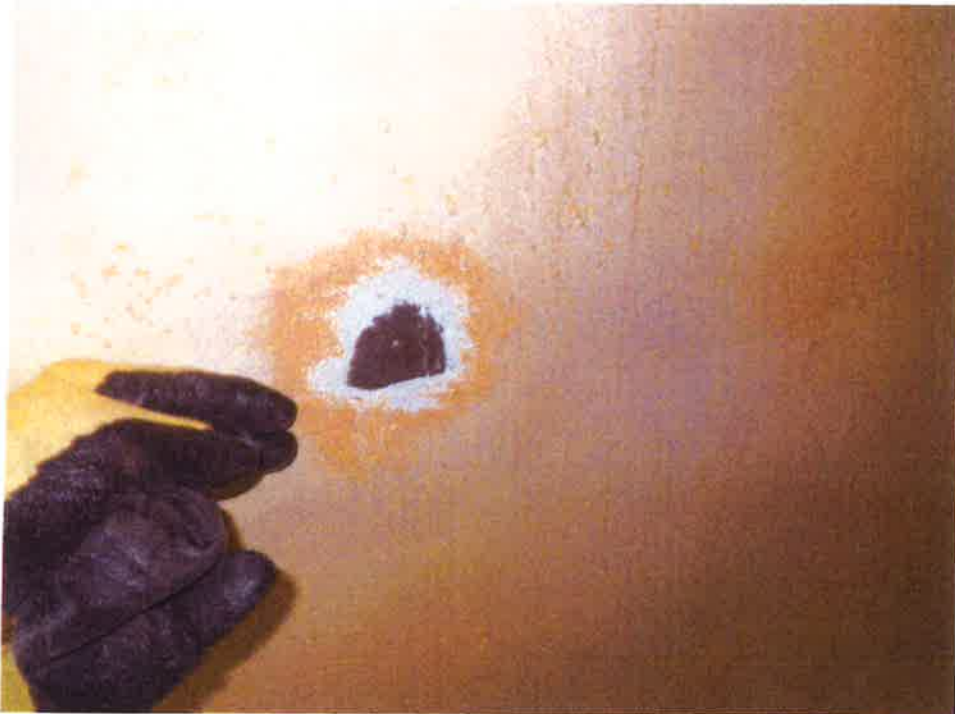
Image #13. May 4th. Small repair sites are hand abraded to feather-edge before bristle blasted to give profile to the surface.

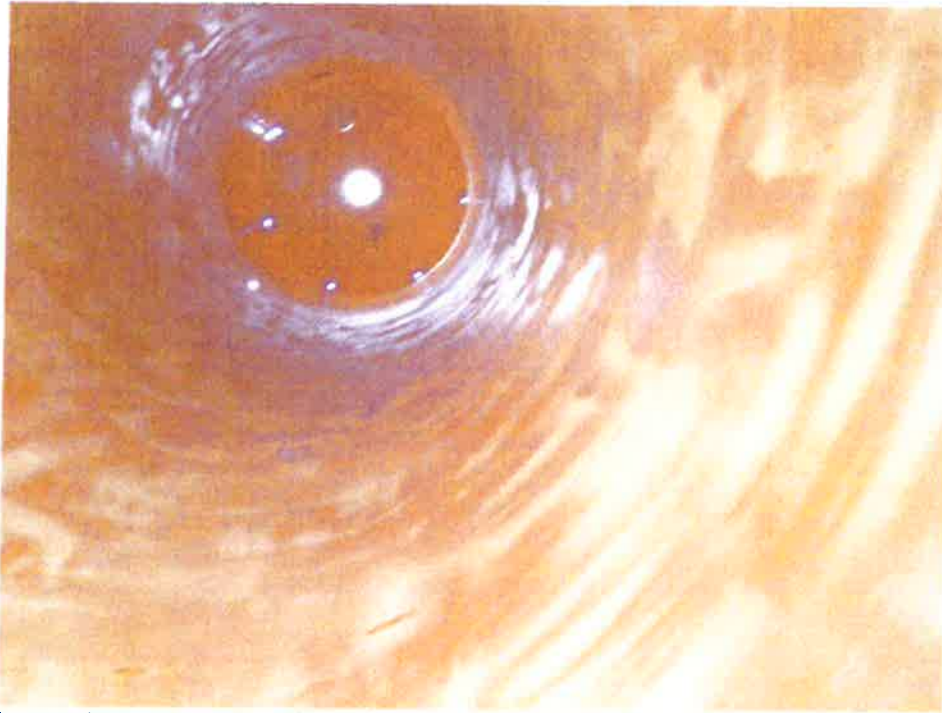
Image #15. May 5th. All repairs completed on walls and weld seams.

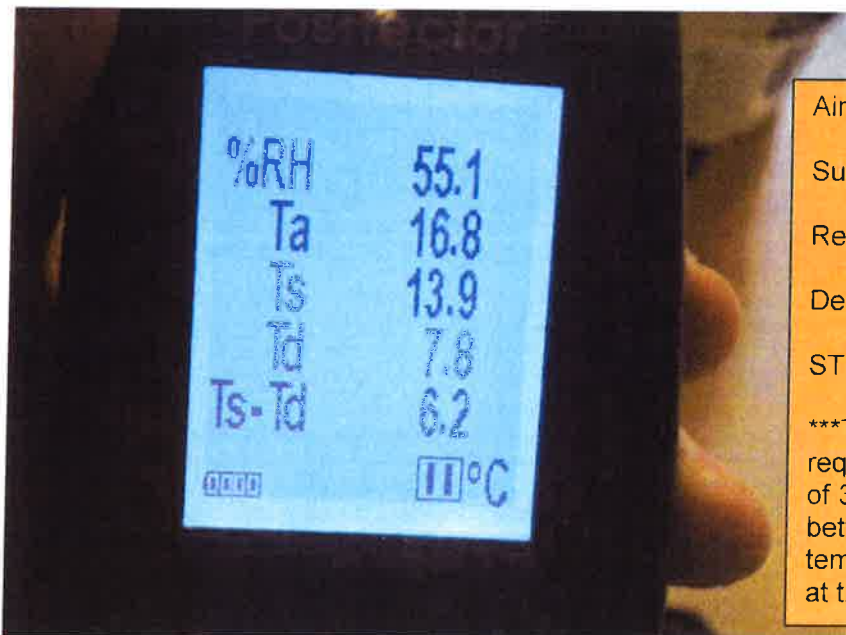
Air Temp:	16.8C
Surface Temp:	13.9C
Relative Humidity:	55.1%
Dew Point:	7.8
ST-DP	= 6.2***
***The coating manufacturer requires a minimum difference of 3 degree Celsius (5F) between the surface temperature and the dew point at the time of paint application.

Image #16. May 5th. All Environmental Measurements taken from various locations within the vessel yielded levels above the coating suppliers requirements.

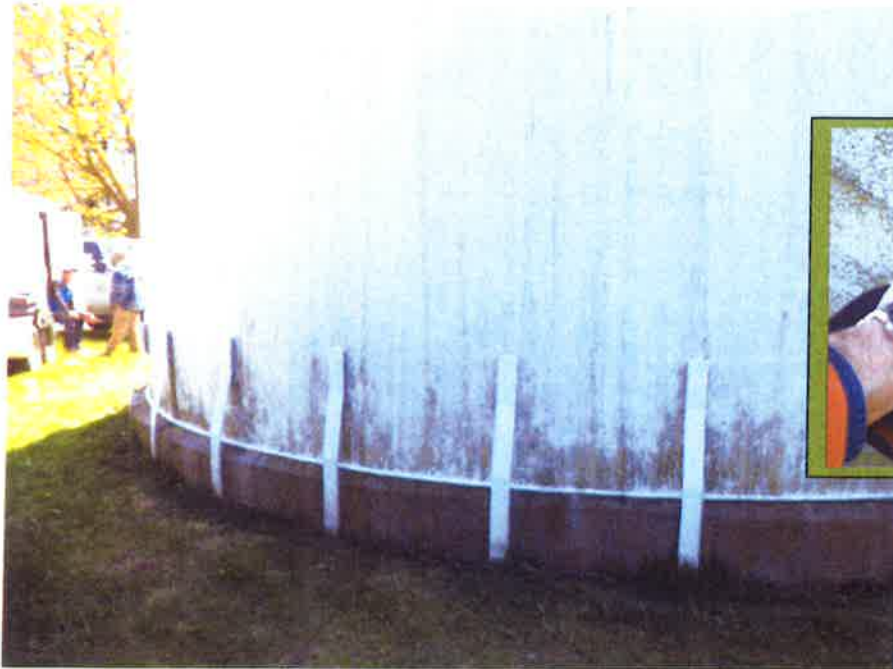
Image #17. May 5th. Mildew visible along bottom of vessel exterior. In some areas, the mold is very thick and well anchored to the surface.

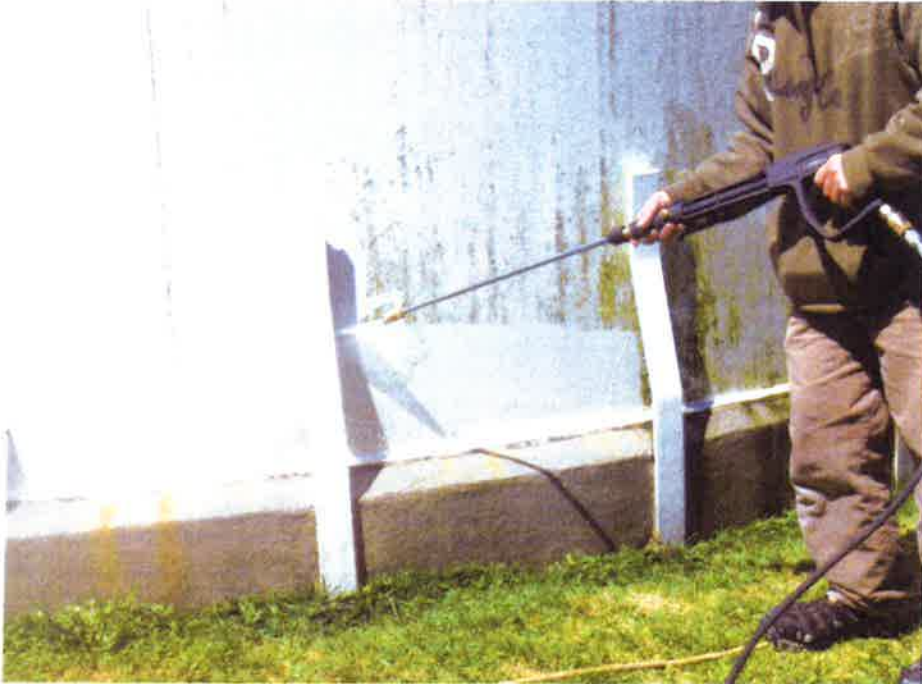
Image #18. May 6th. Contractor using high pressure water washer to remove mildew.

At the completion of the coating repair work, the contractor spent time to clean the bottom ring of the vessel. A small, high pressure water wash unit was attached by the operator (CH2MHill personal) to a nearby hydrant. Image 17, 18 & 19.

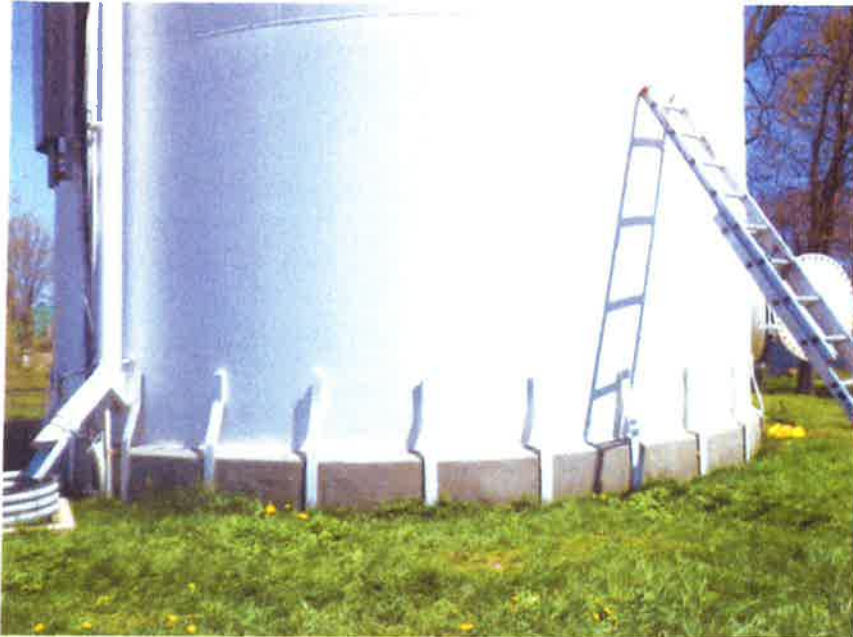
Image #19. May 6th. Cleaned area of the bottom ring.
